"ADVANCE AND RELIEVE" MINING, A METHOD TO MITIGATE THE AFFECTS OF HIGH HORIZONTAL STRESS ON THE MINE ROOF

D. R. Dolinar, T. P. Mucho, and D. C. Oylar
Nat'l Inst for Occupinl Sfty and Health
Pittsburgh, PA, USA

ABSTRACT

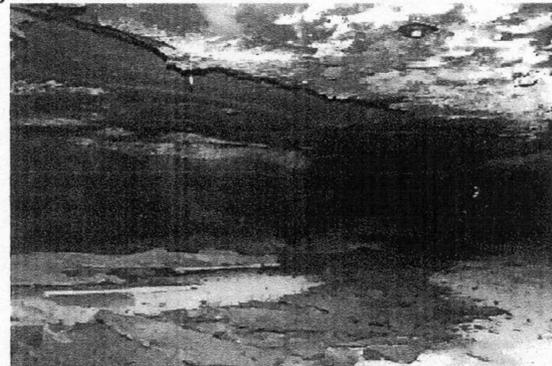
Figure 4. Stress induced cutter roof failure

Mapping of the stress damage also indicates the directional nature of the roof problem by documenting more subtle roof damage in addition to roof falls (Mucho and Mark, 1994). This stress damage is in the form of cutters or gutters (figure 4). In the panels, most of the stress damage again occurred in the N 30° W entries. In panel E13 about 23% of the drivage had stress damage in the form of cutters or guttering. Ninety-five percent of this damage was in the N 30° W entries with 45% of the drivage in this direction suffering stress damage.

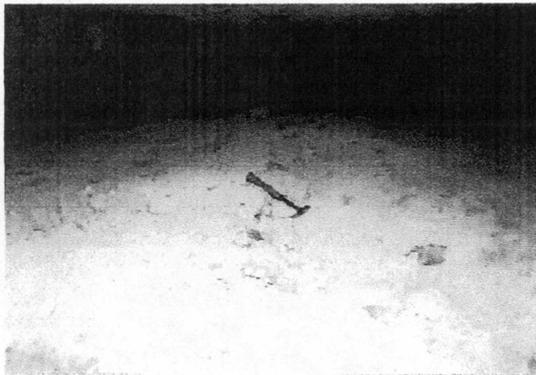
Figure 12. Floor heave experienced in E15 panel

With the start of "advance and relieve" pillaring in both panels E15 and E17, significant floor heave developed. For these panels, the floor geology consisted of 0.3 m to 0.6 m of shale underlain by 1.2 to 1.5 m of fireclay while the overburden averaged 210 m. Figure 12 shows typical floor heave that occurred. Systematic roof to floor convergence measurements were made in the intersections of the belt, L1 and L2 entries along the length of each panel.

The maximum floor heave occurred in both panels during the first 245 m of "advance and relieve" pillaring. In E15 the average heave rate in this panel section was 0.6 cm/day, while in E17 the average rate was 0.96 cm/day. These rates were maintained for periods of up to 40 to 60 days before leveling off. In places, 50 to 75 cm of floor heave resulted. The floor heave occurred across the panel width and was not confined to the area adjacent to the cave. Figure 13 shows the pattern of floor heave over time across the E17 panel 60 m in by the start of pillaring. The accelerated rate of floor heave shown in figure 13 after 115 days is the result of retreat mining in the

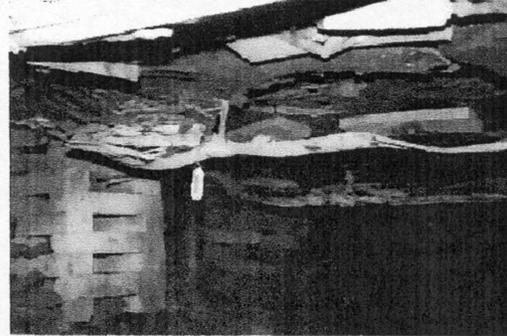
Figure 17. Rear abutment stress damage in L1 entry

To rehabilitate the damaged roof, cribs, posts and cable bolts were used as supplemental support in the R1 entry and across the panel along the narrow zone of damage. Similar, though not as severe damage was seen outby the cave in E17. Again supplemental support was used to control the stress damage. In E17 the damage approached but did not reach the mains.
